Gas Plant Remediation Project Profile

Contaminated Site Assessment
and Remediation

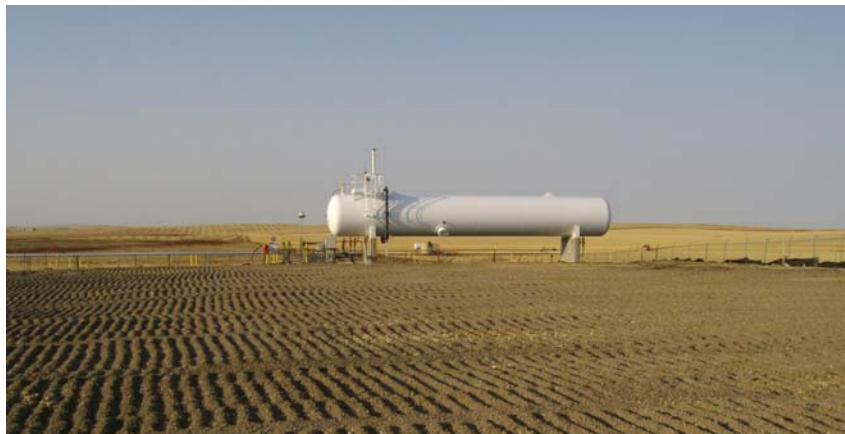
For more information on this project contact Darrell Haight, P.Ag., President at 780.458.7787. The photo below shows the remediated work area. The NGL bullet remained operating during remediation.
